Repair Summary

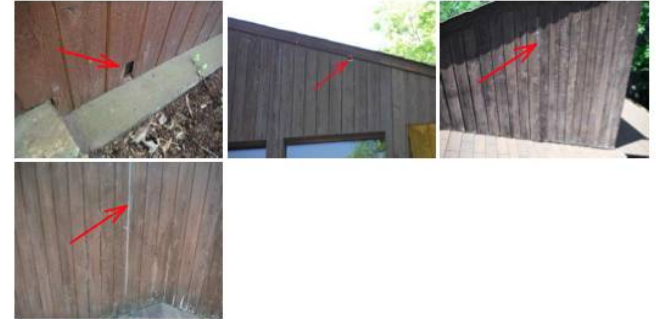
Some sealant has been installed between the seams of some of the siding on the right

side of the property. This may be an indication of a previous leak. R consulting with the current owner as to the nature of the repair. Rec monitoring.
